Report of Eddy Current Inspection

Manufacturer: York

Model: YSCBCA

Location: SHELBY COUNTY JUVENILE COURT
616 ADAMS
SOUTH CHILLER
MEMPHIS, TN 37501

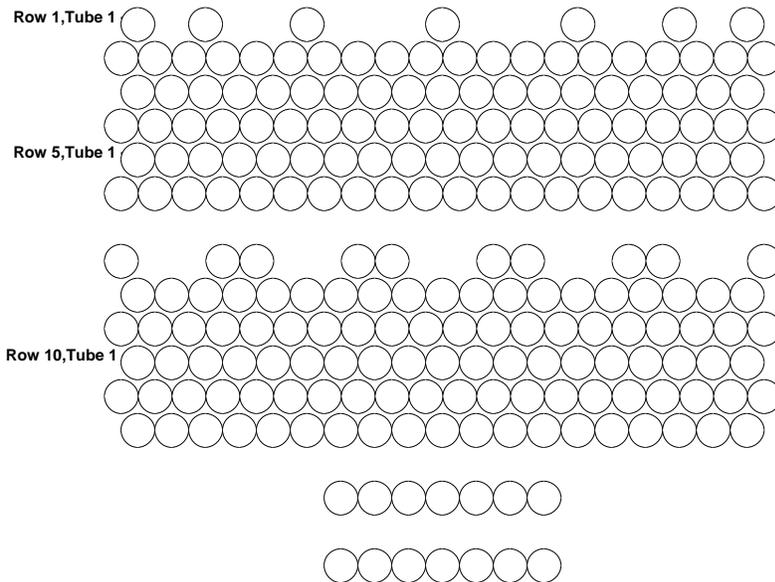
Condenser Section

No Significant defects were found.

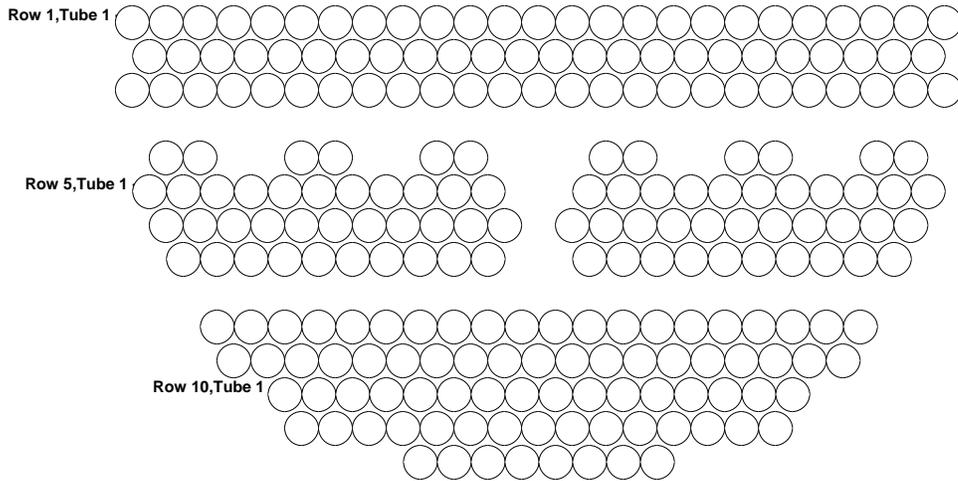
Evaporator Section

No Significant defects were found.

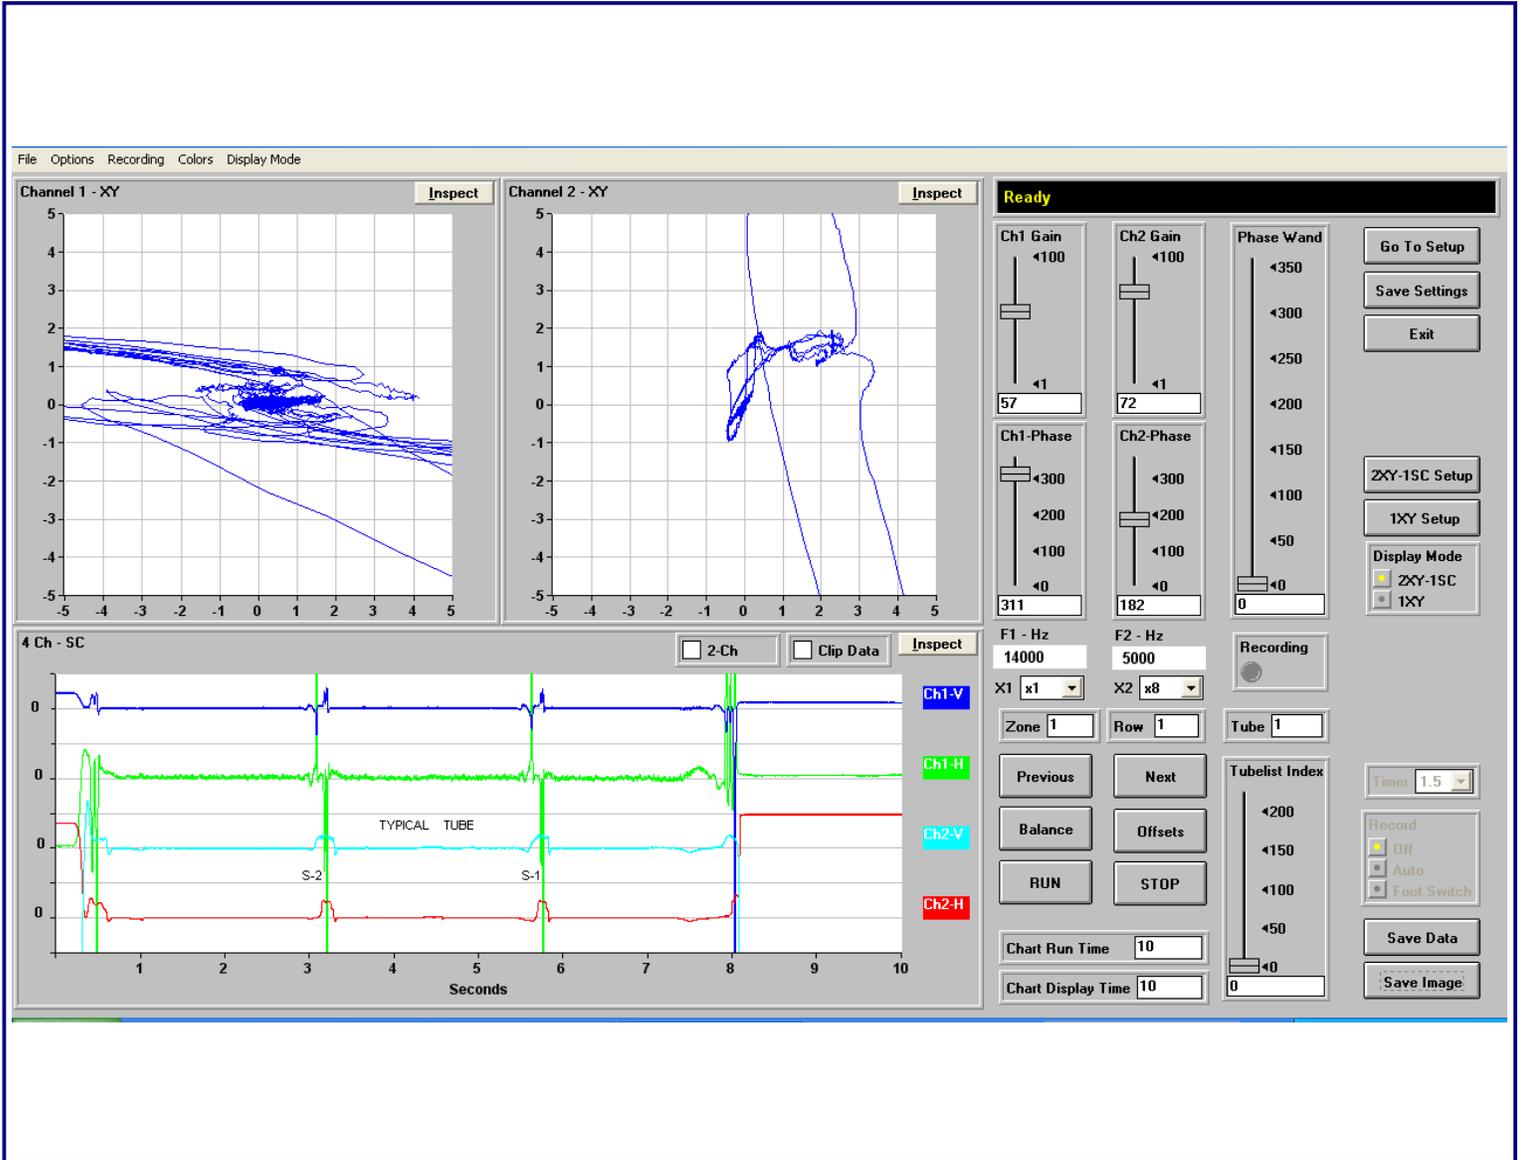
Condenser Section

NO SIGNIFICANT DEFECTS (Row 1 Tube 1)

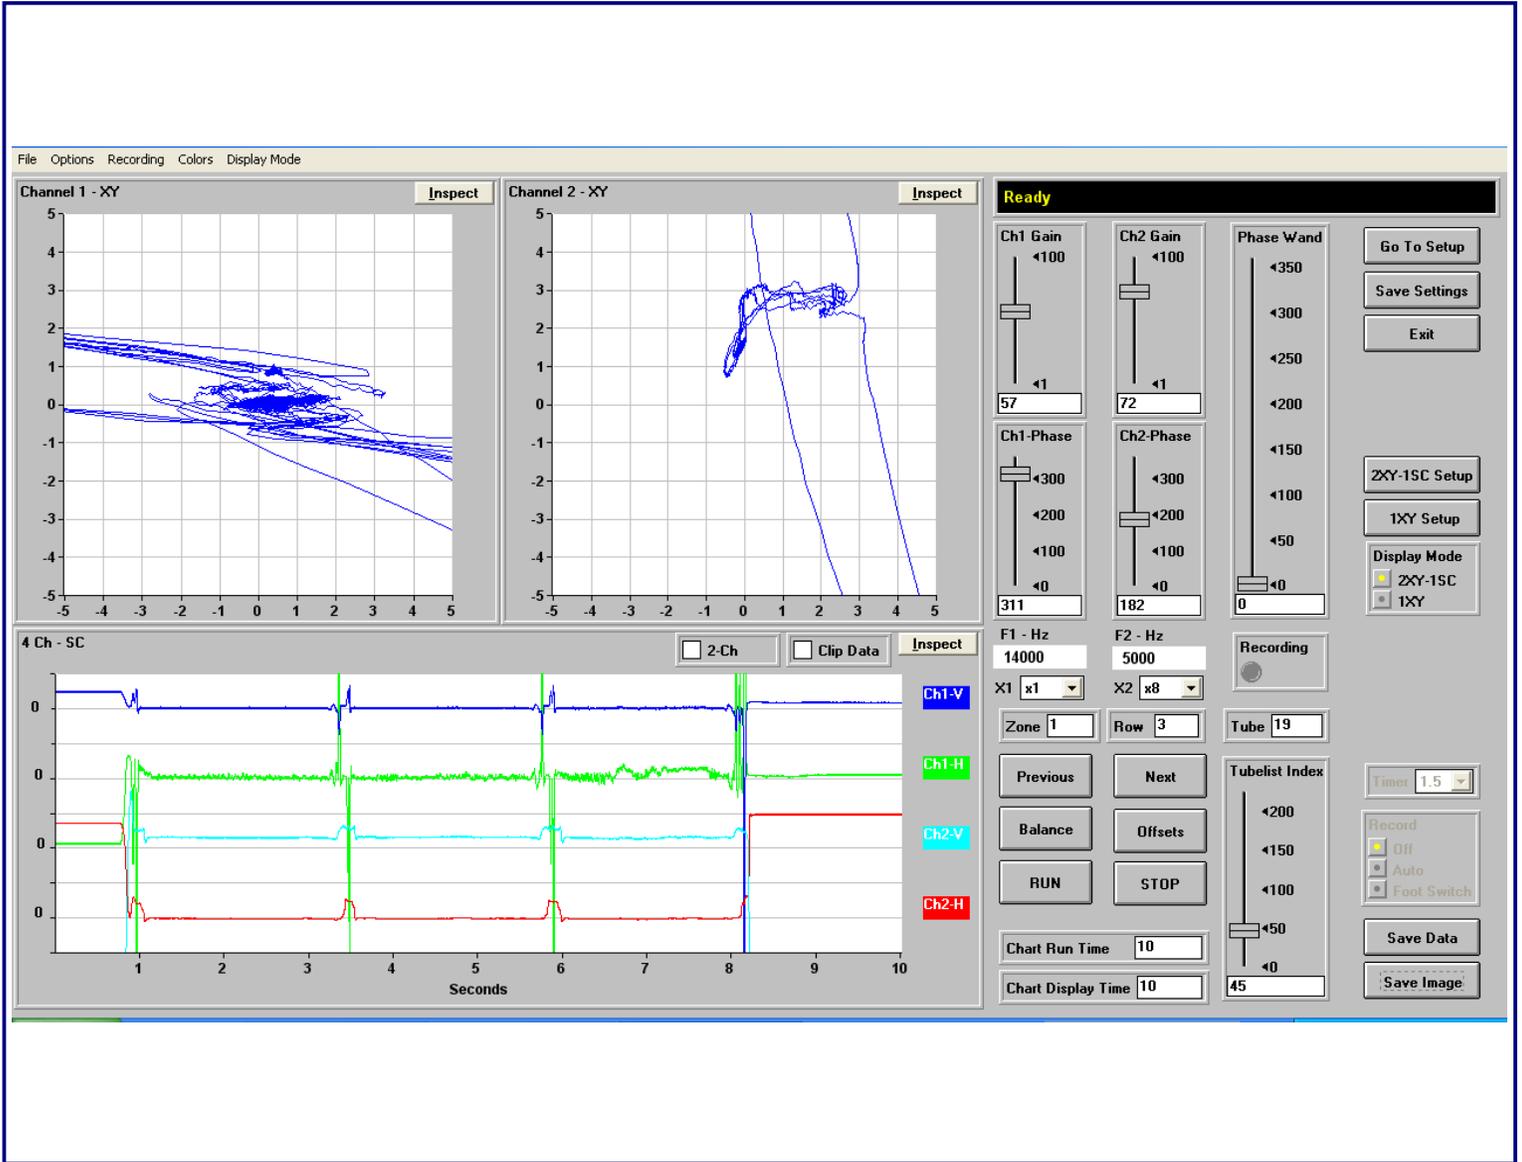
Condenser Section

NO SIGNIFICANT DEFECTS (Row 3 Tube 19)

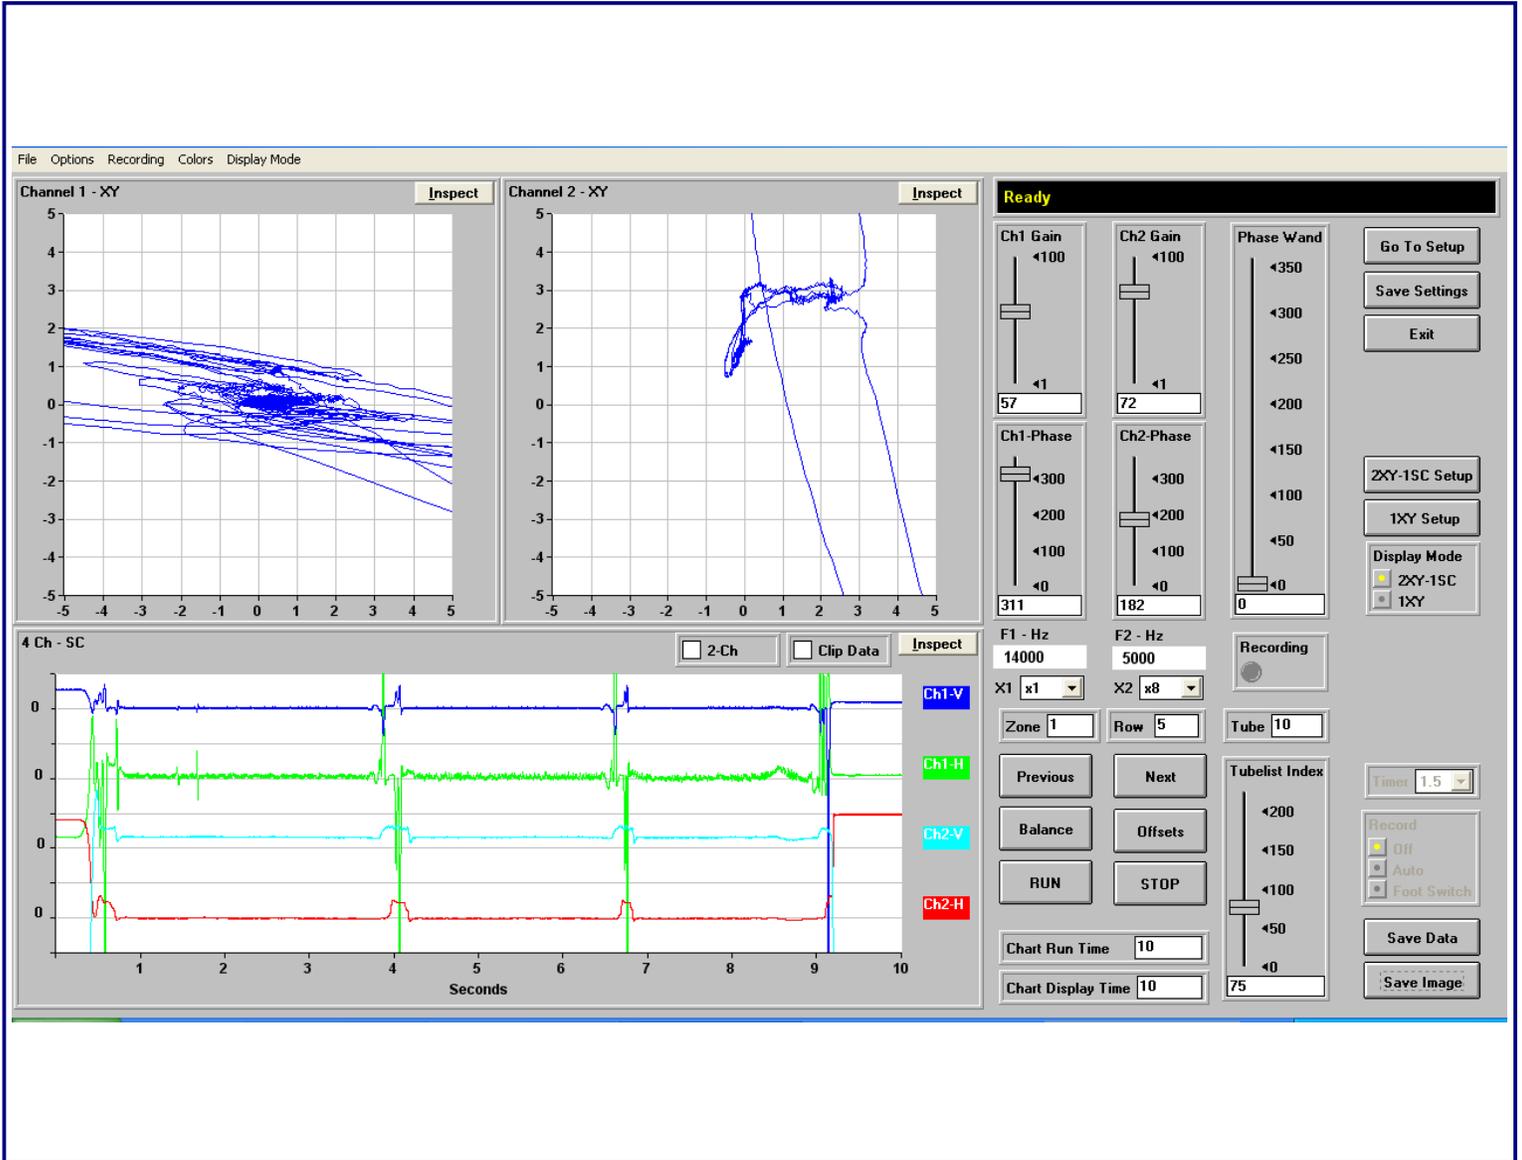
Condenser Section

NO SIGNIFICANT DEFECTS (Row 5 Tube 10)

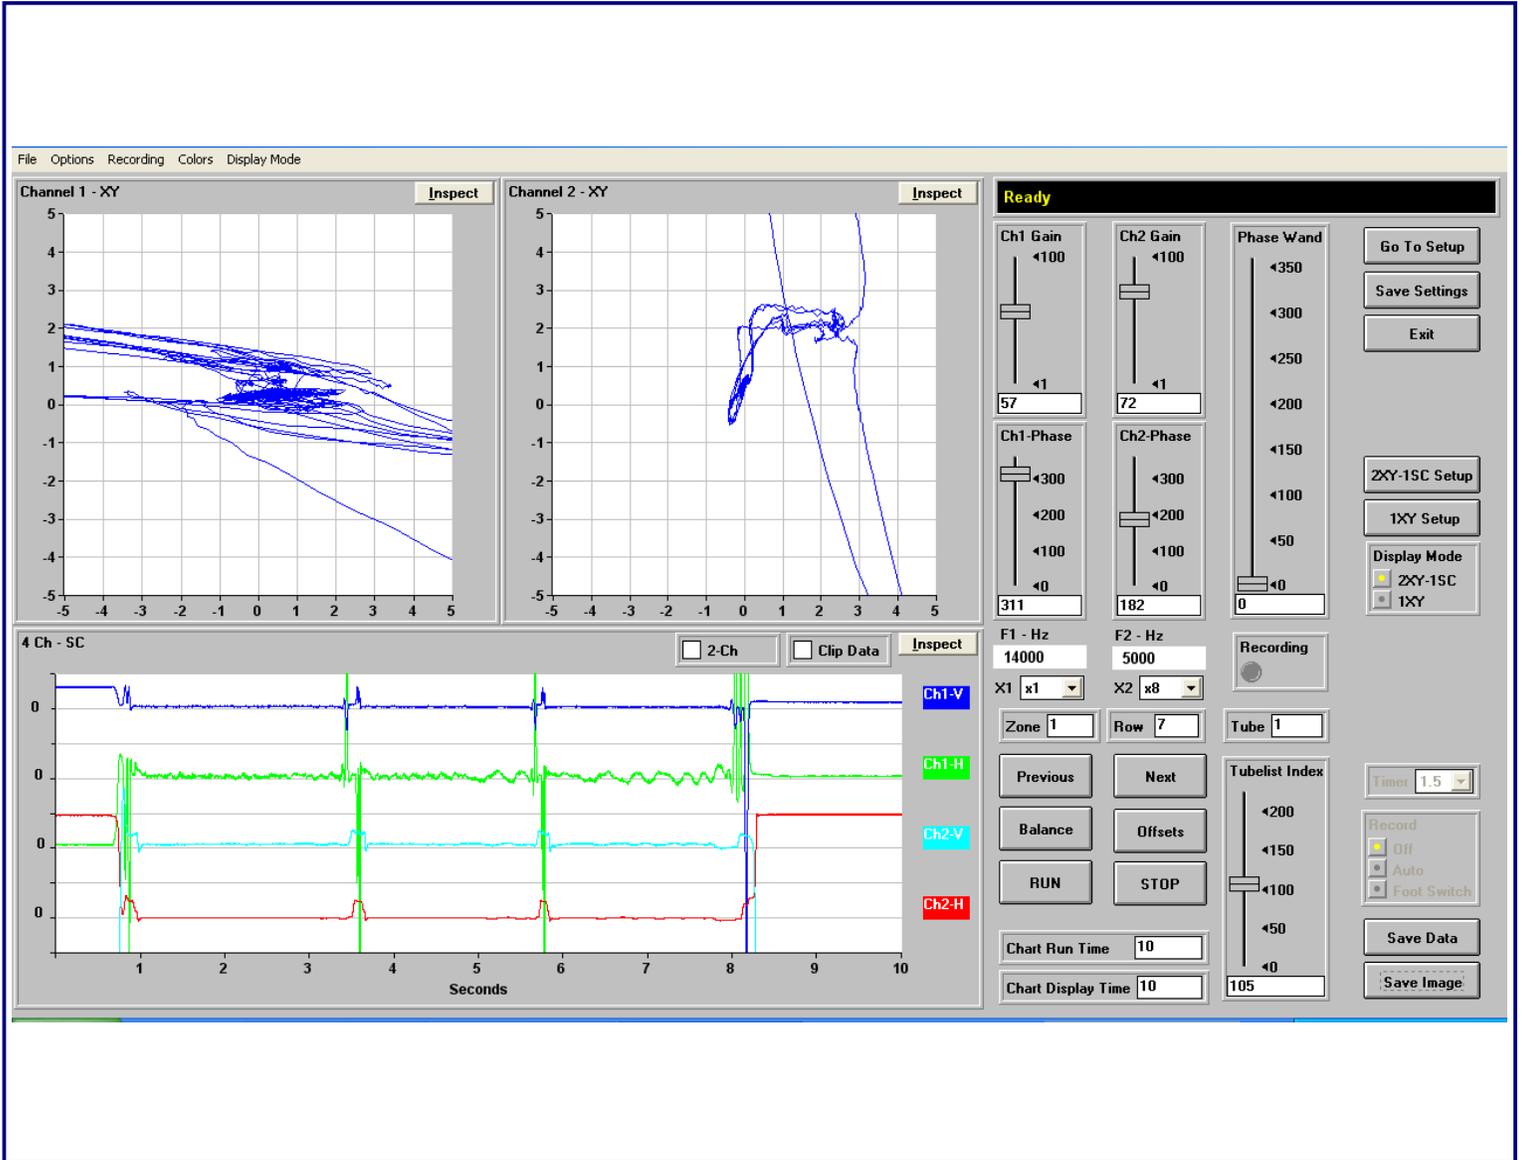
Condenser Section

NO SIGNIFICANT DEFECTS (Row 7 Tube 1)

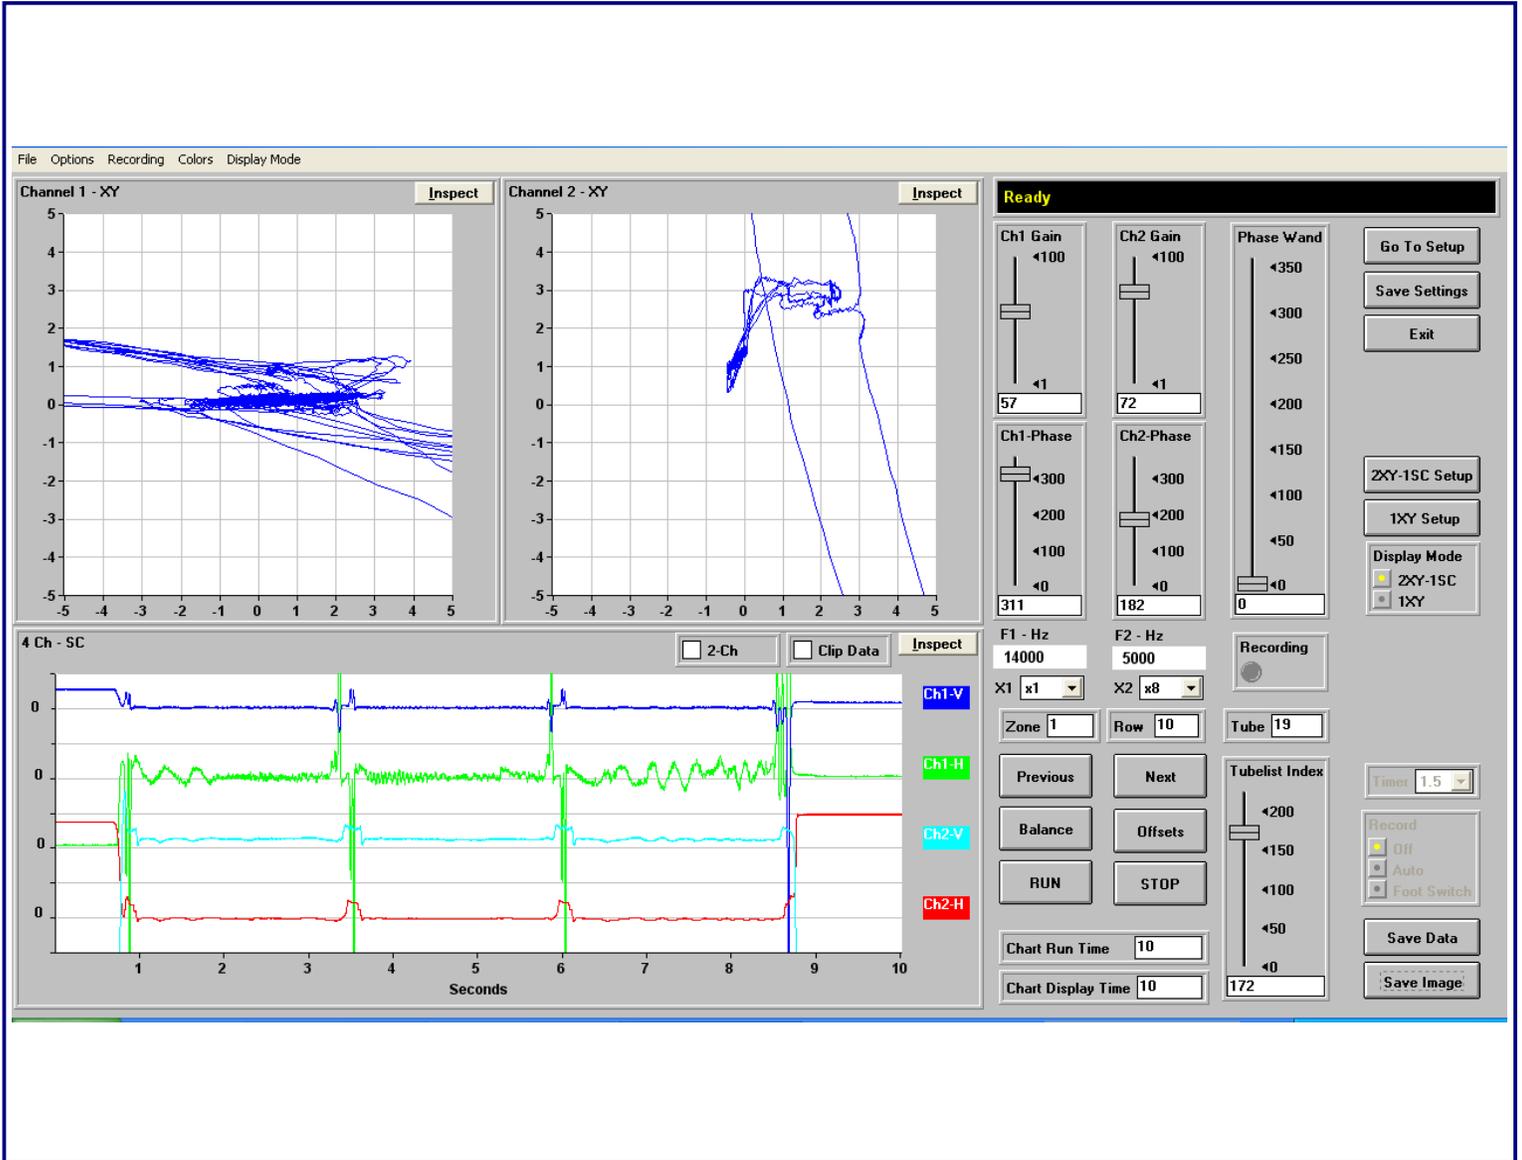
Condenser Section

NO SIGNIFICANT DEFECTS (Row 10 Tube 19)

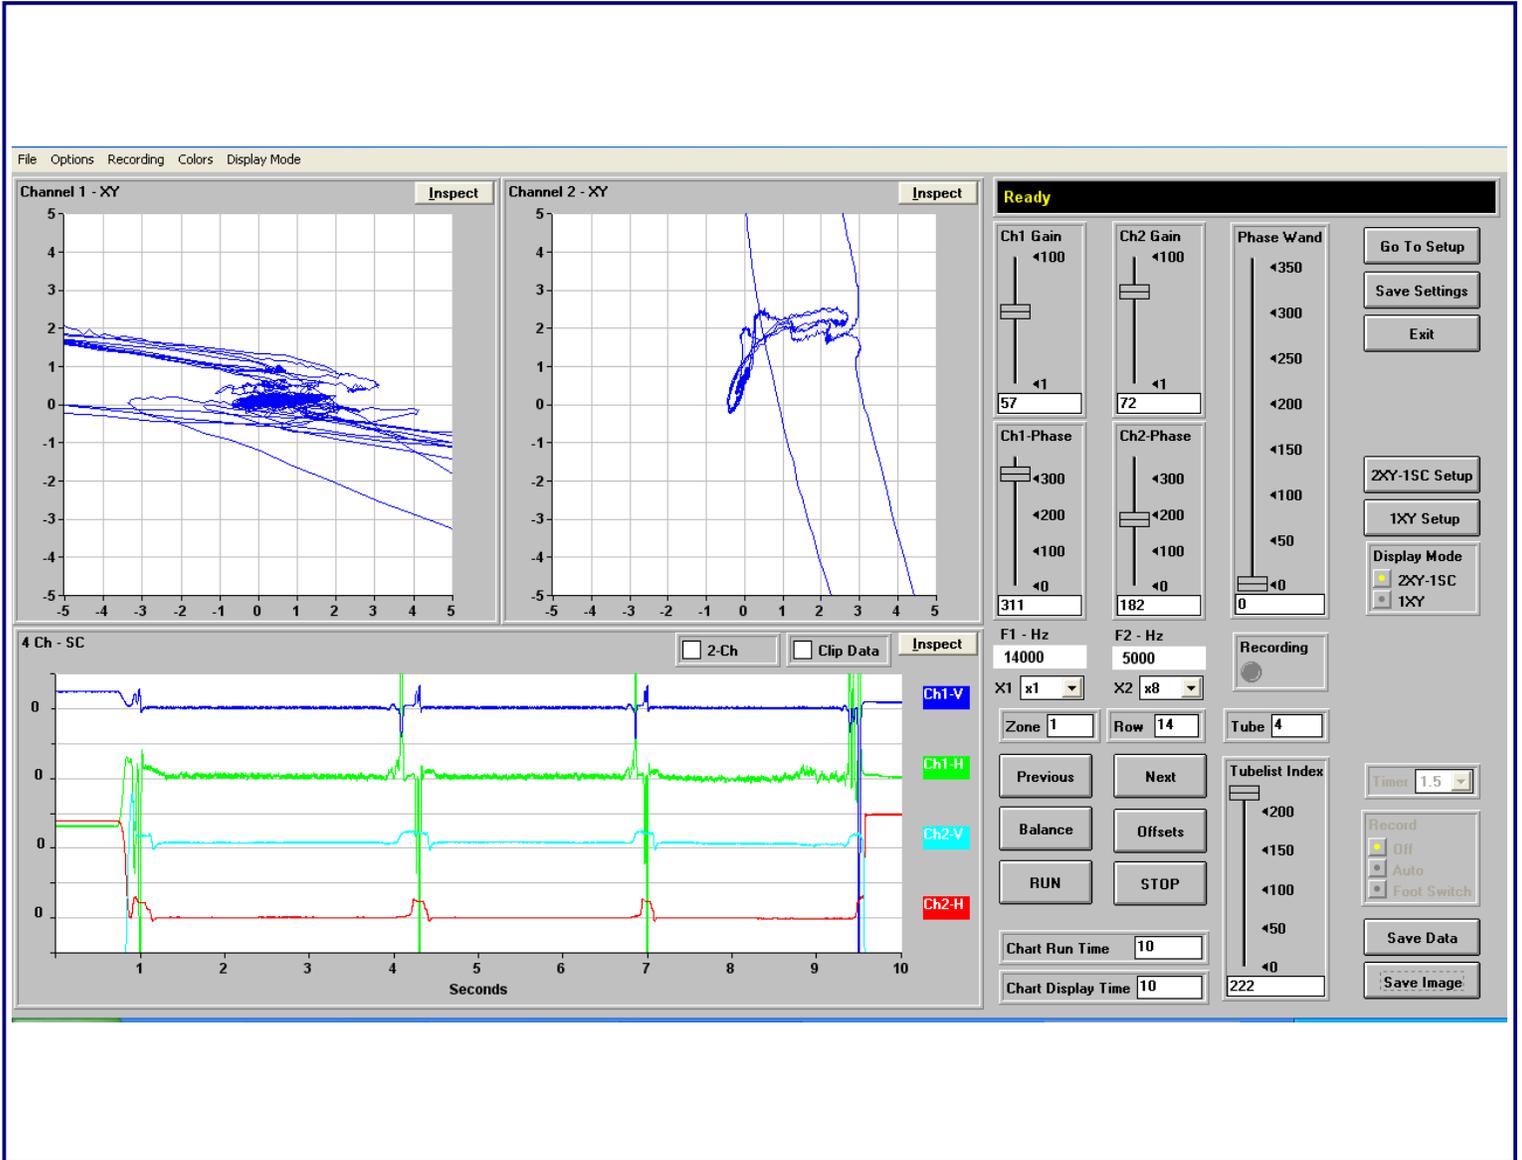
Condenser Section

NO SIGNIFICANT DEFECTS (Row 14 Tube 4)

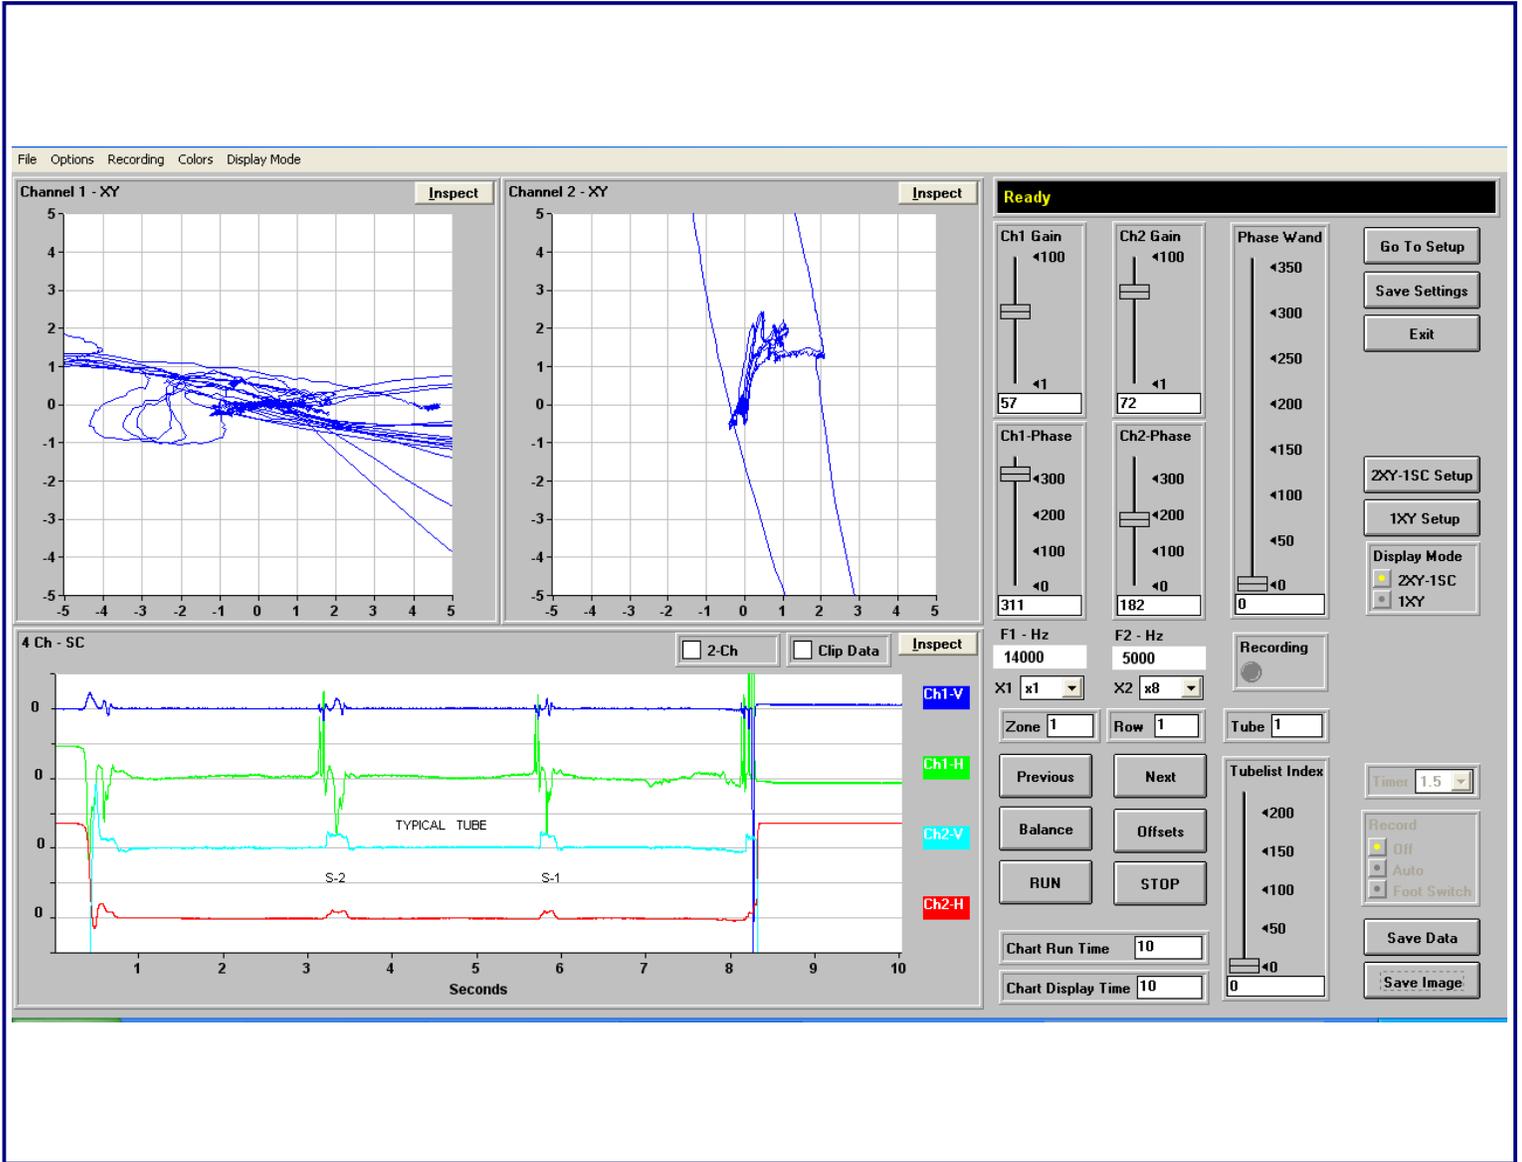
Evaporator Section

NO SIGNIFICANT DEFECTS (Row 1 Tube 1)

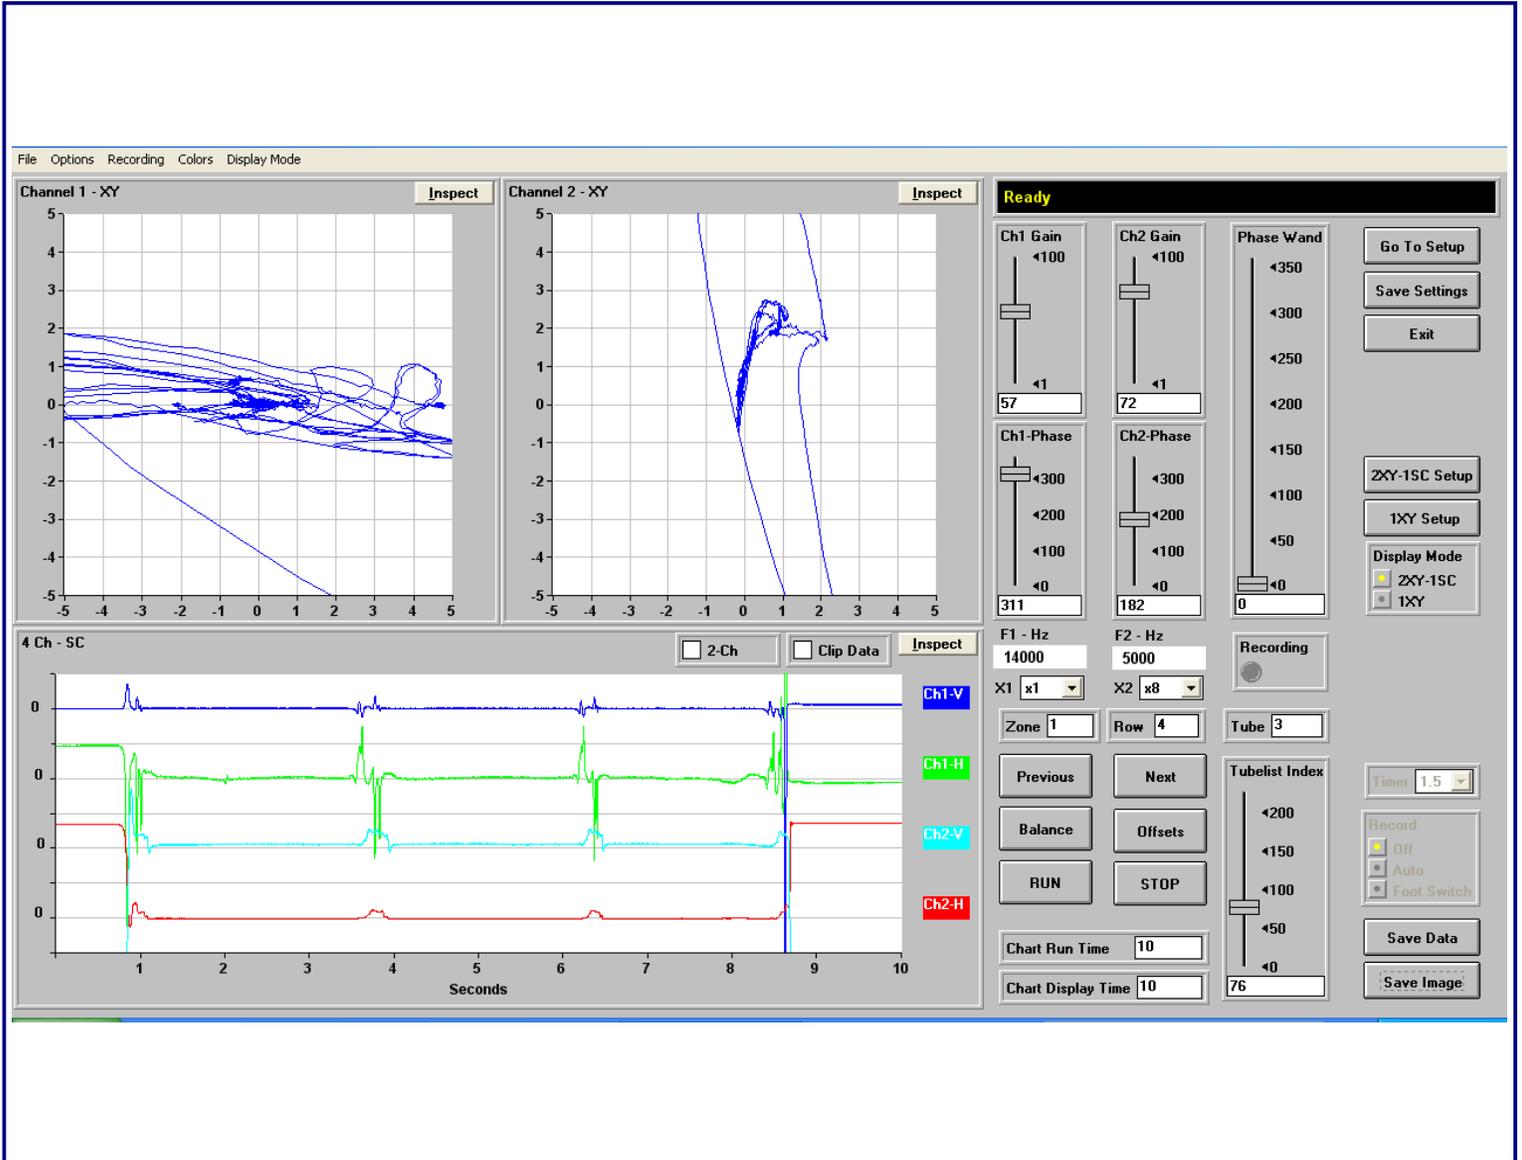
Evaporator Section

NO SIGNIFICANT DEFECTS (Row 4 Tube 3)

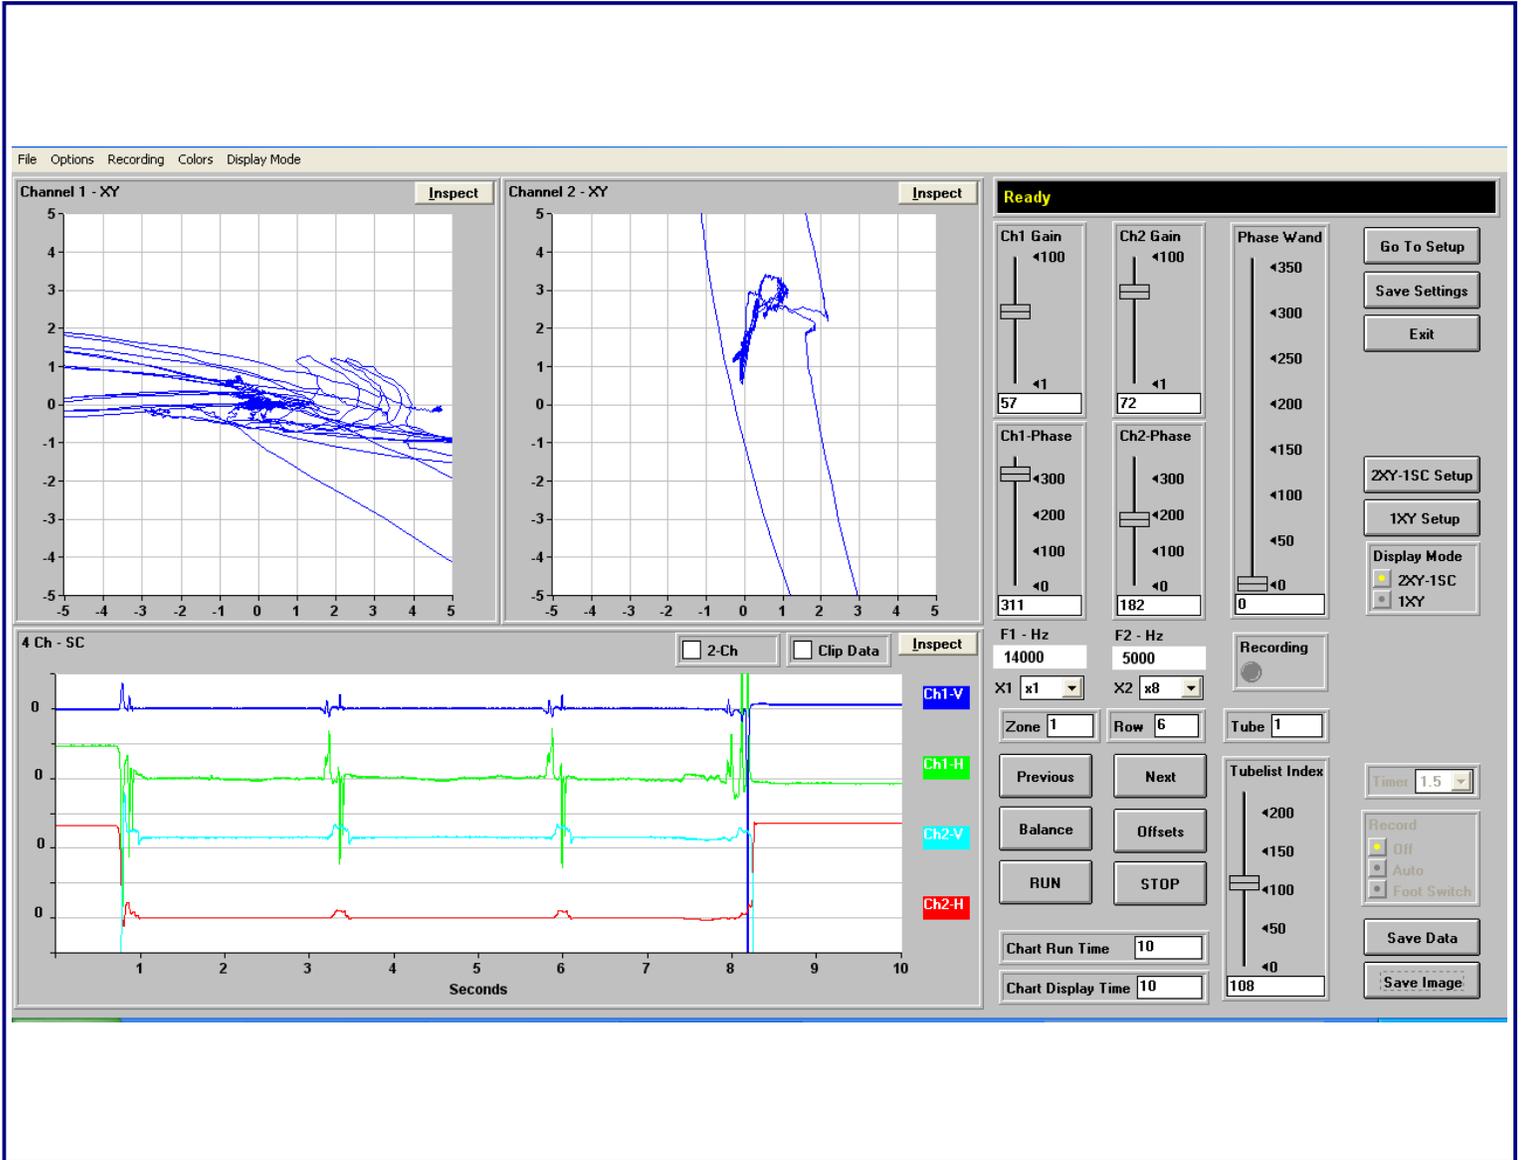
Evaporator Section

NO SIGNIFICANT DEFECTS (Row 6 Tube 1)

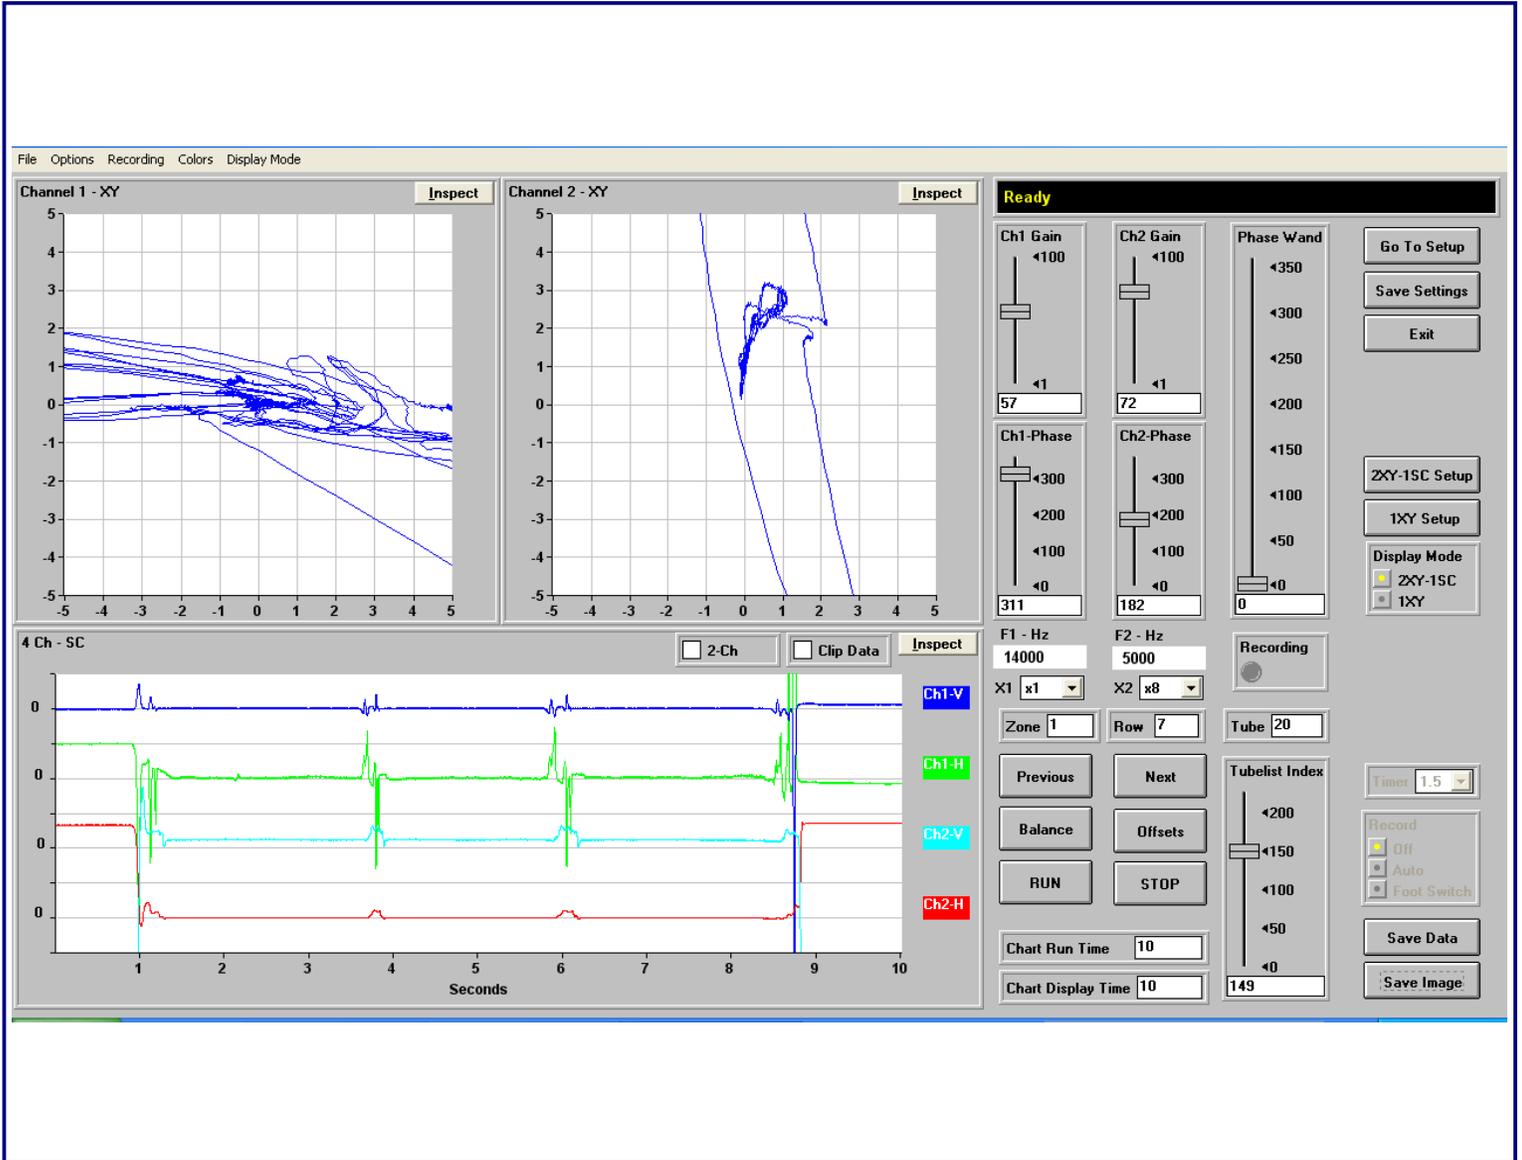
Evaporator Section

NO SIGNIFICANT DEFECTS (Row 7 Tube 20)

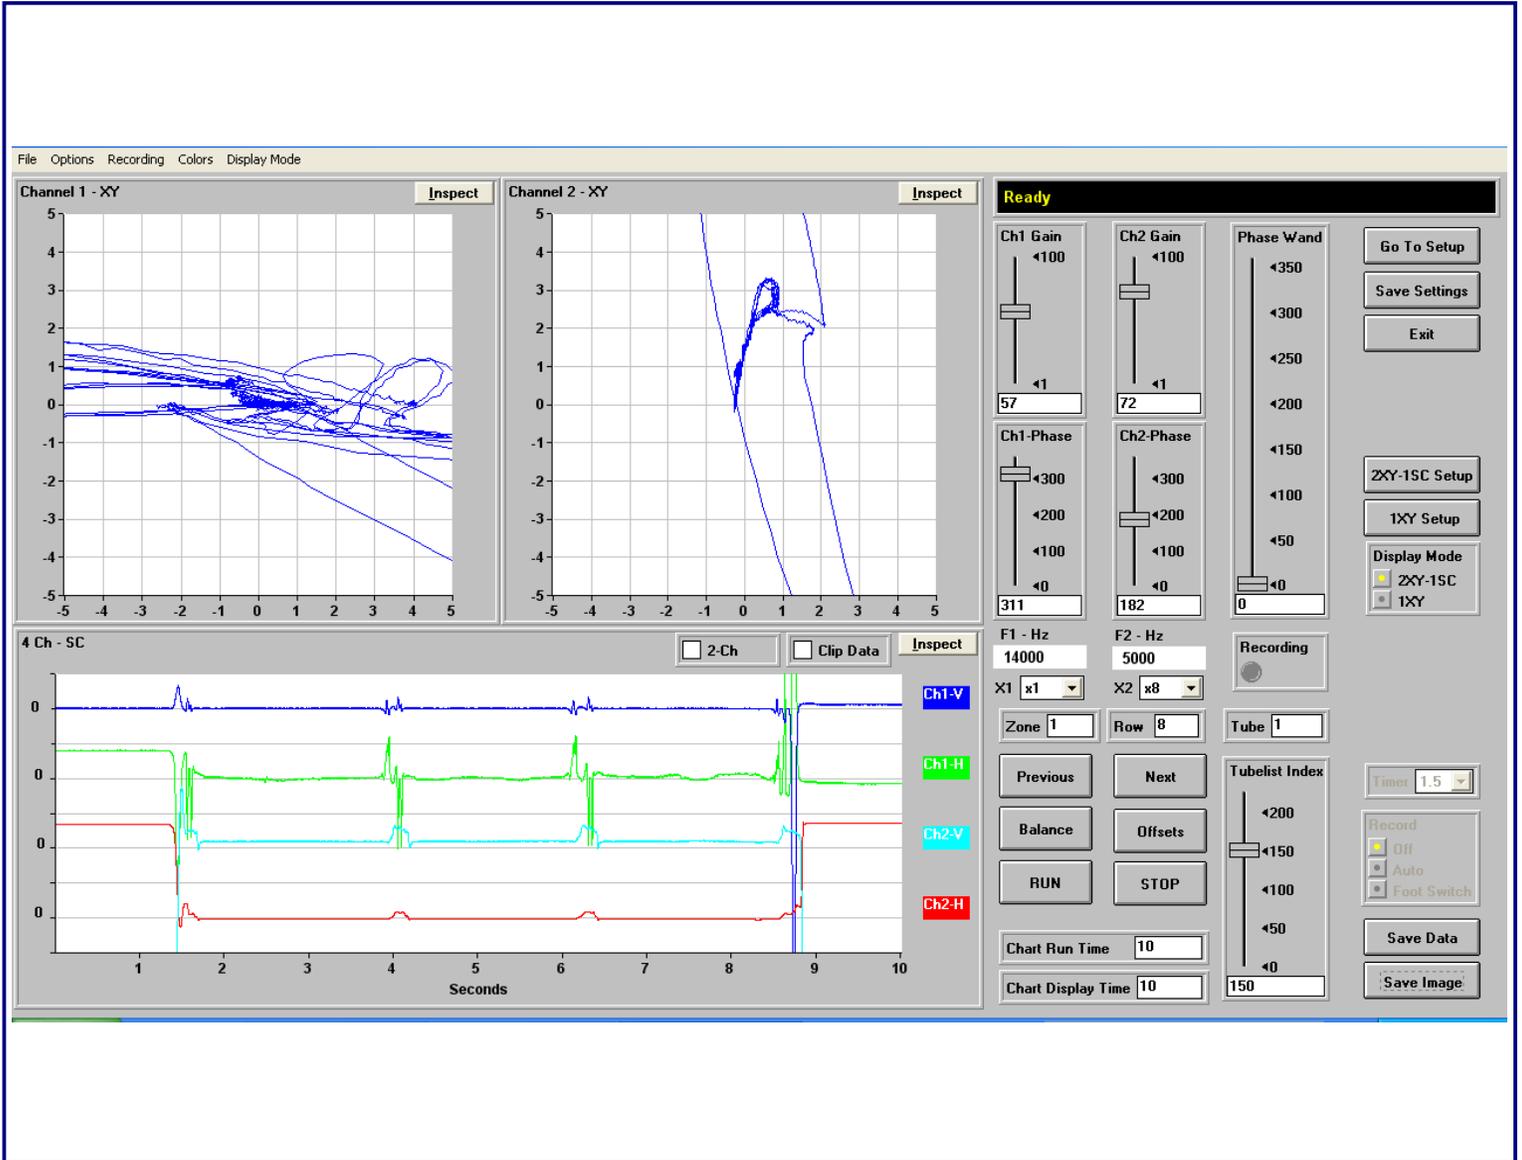
Evaporator Section

NO SIGNIFICANT DEFECTS (Row 8 Tube 1)

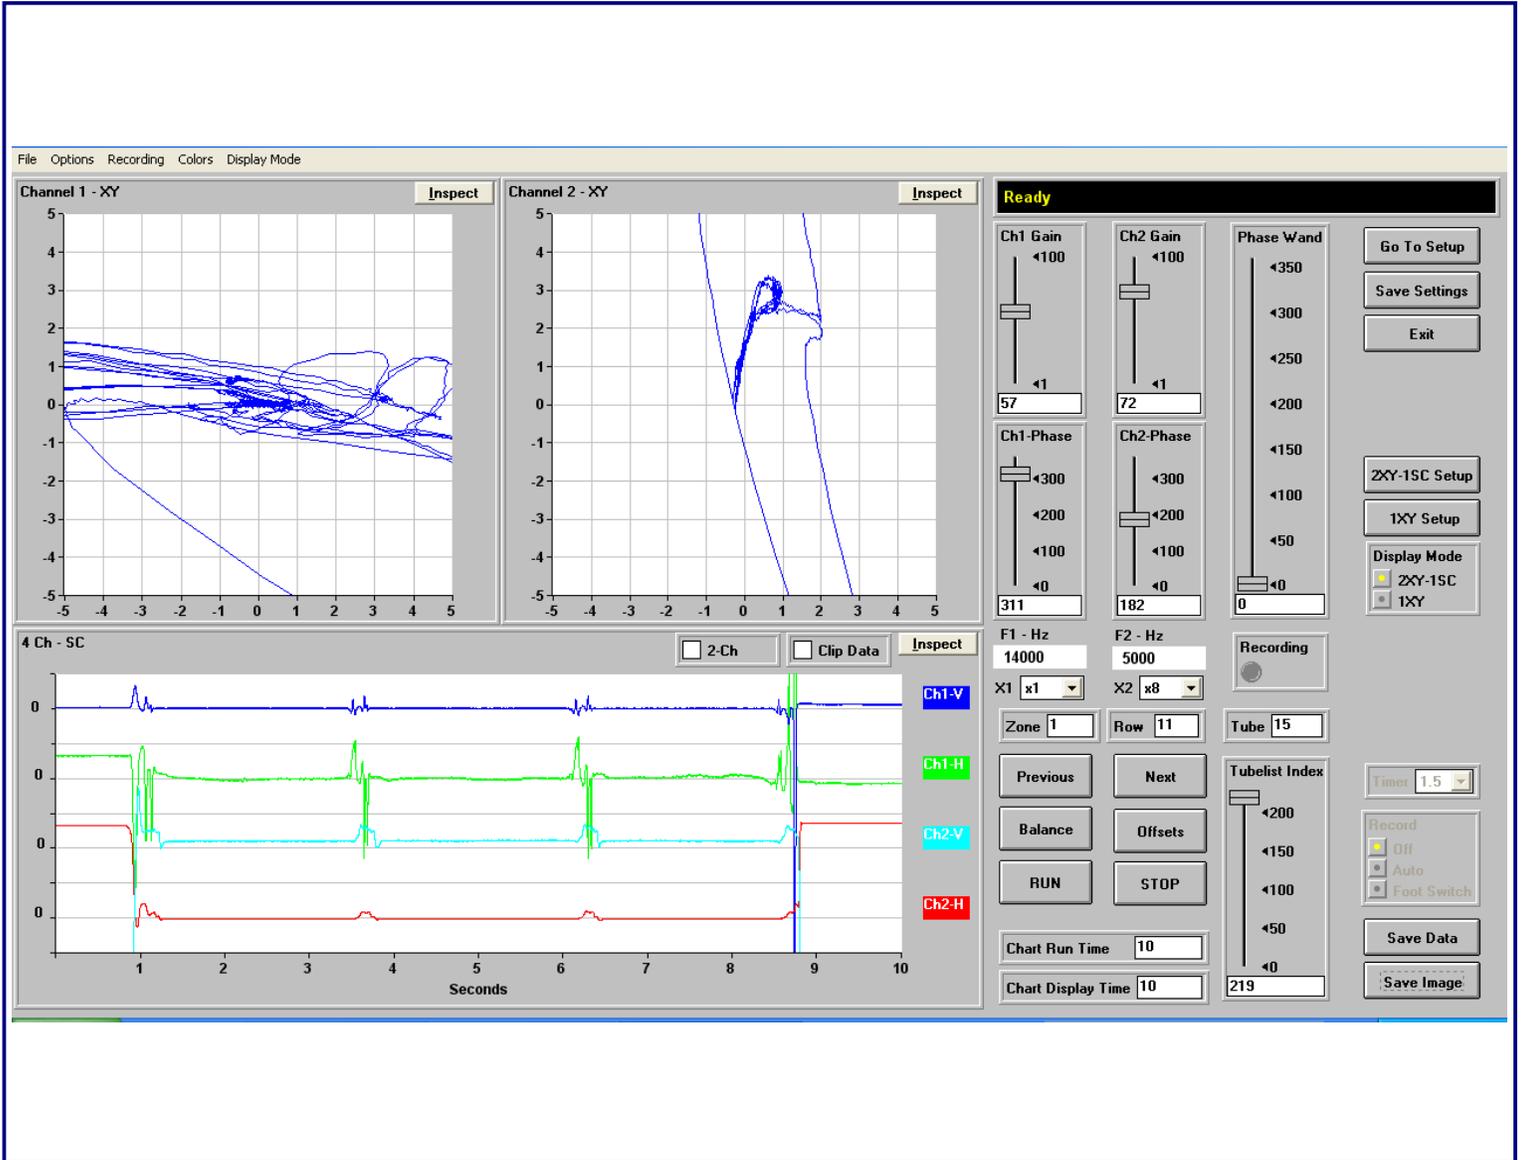
Evaporator Section

NO SIGNIFICANT DEFECTS (Row 11 Tube 15)
